Name Of Dam: Greene Acres

Location: Greene County, State of Virginia

Inventory Number: VA 07903

PHASE I INSPECTION REPORT NATIONAL DAM SAFETY PROGRAM

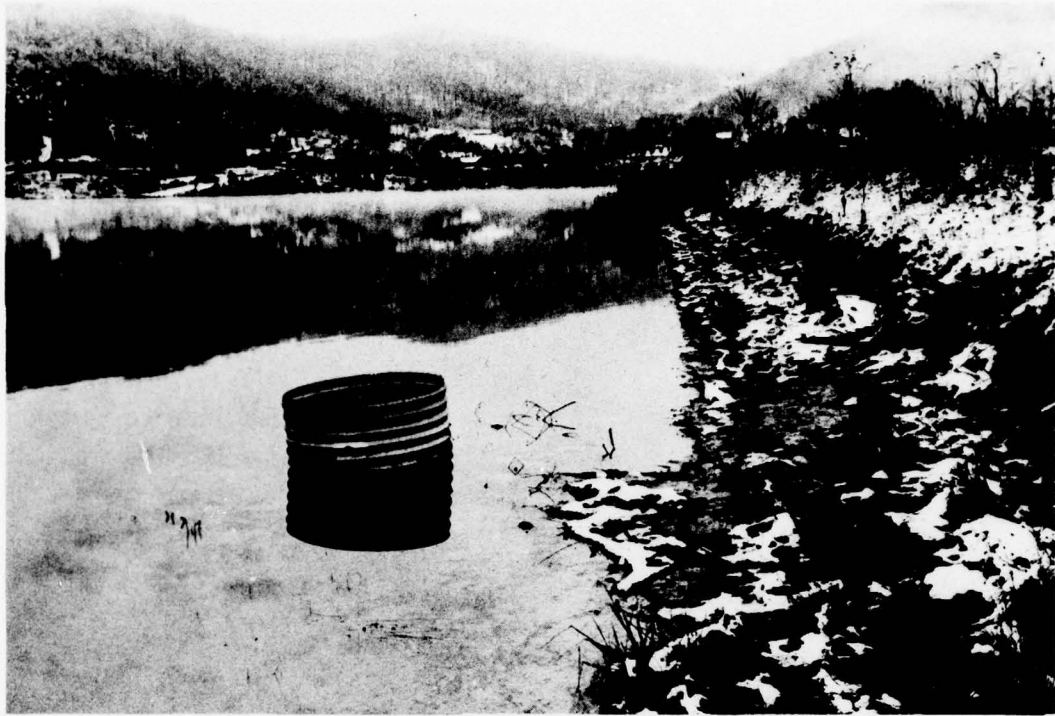
3.1.3 Appurtenant Structures: The inlet and outlet of the 24 inch C.M.P. overflow pipe appear to be in good physical condition and are able to function properly (see Photos 1 and 2). Water was about 0.5 foot below the crest of the overflow pipe. The 10 inch submerged blow-off pipe with a closed gate valve appears to be functional (see Photo 4). Water is ponded at the outlet of the pipe toe drain.

PHOTO 1. Corrugated Outlet Pipe Near Right Abutment

VISUAL EXAMINATION OF	OBSERVATIONS	REMARKS OR RECOMMENDATIONS
CRACKING AND SPALLING OF CONCRETE SURFACES IN OUTLET CONDUIT	Normal outlet conduit is a 24 in. C.M.P. through the embankment which discharges into a "Y" shaped concrete channel which runs along the downstream right abutment of the dam. Concrete in this channel shows no unusual cracking or spalling.	
INTAKE STRUCTURE	The intake structure consists of a vertical section of 24 in. diameter C.M.P. (invert elevation of 95.0 ft. P.D.) turning 90°, running 73 ft. through the embankment near the right abutment, and exiting at an elevation of 88.0 ft. P.D. The 24 in. inlet has a 2 ft. section of 36 in. diameter C.M.P. around it which serves as a trash shield.	
OUTLET STRUCTURE	The 24 in. C.M.P. exits into the "Y" shaped channel which runs toward the toe of the dam along the right abutment near the junction with the dam embankment (see Photo 1).

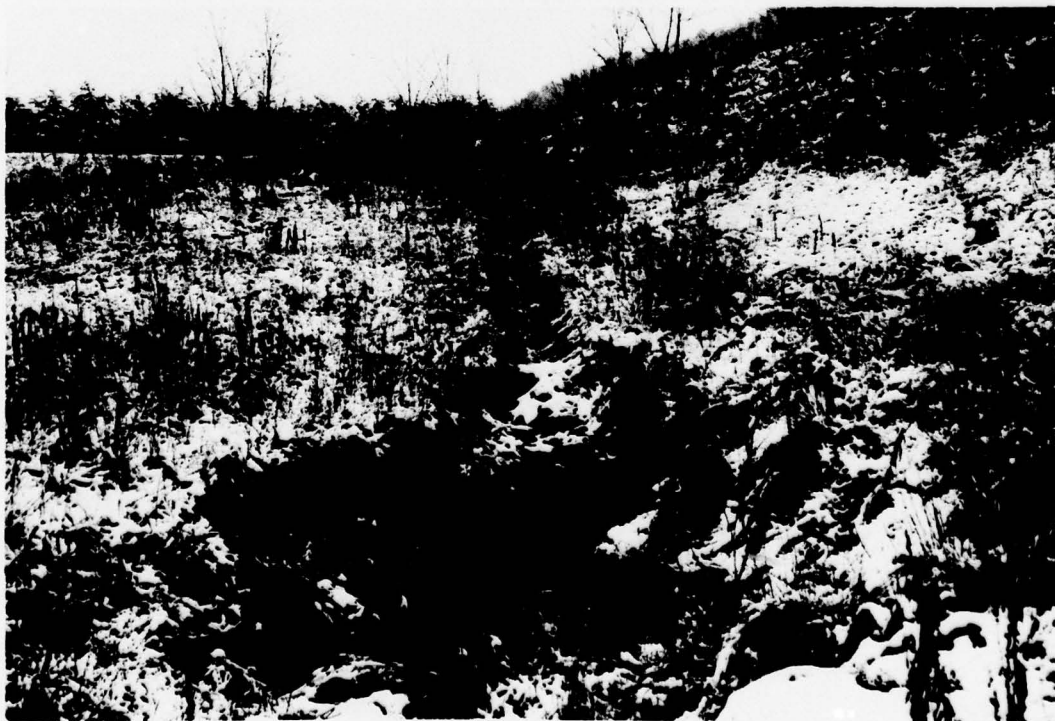
Erosion was evident where the open concrete channel from the overflow pipe ends and the natural channel begins. Although the natural channel appears to have eroded to rock, any erosion at or near the toe of an earth dam is not desirable and should be remedied. Severe erosion from wave action was also evident on the upstream slope of the embankment along its entire length and has created a steep condition above normal pool. There was some erosion observed in the emergency spillway due primarily to the lack of adequate grass cover. However, the spillway size and discharge slope is sufficient to divert high discharges away from the embankment.

PHOTO 2. Concrete Lined Drainage Channel From Outlet Pipe and Eroded Area

The owner should provide wave erosion protection on the upstream slope, and repair and protect eroded sections of the downstream toe near the overflow pipe.

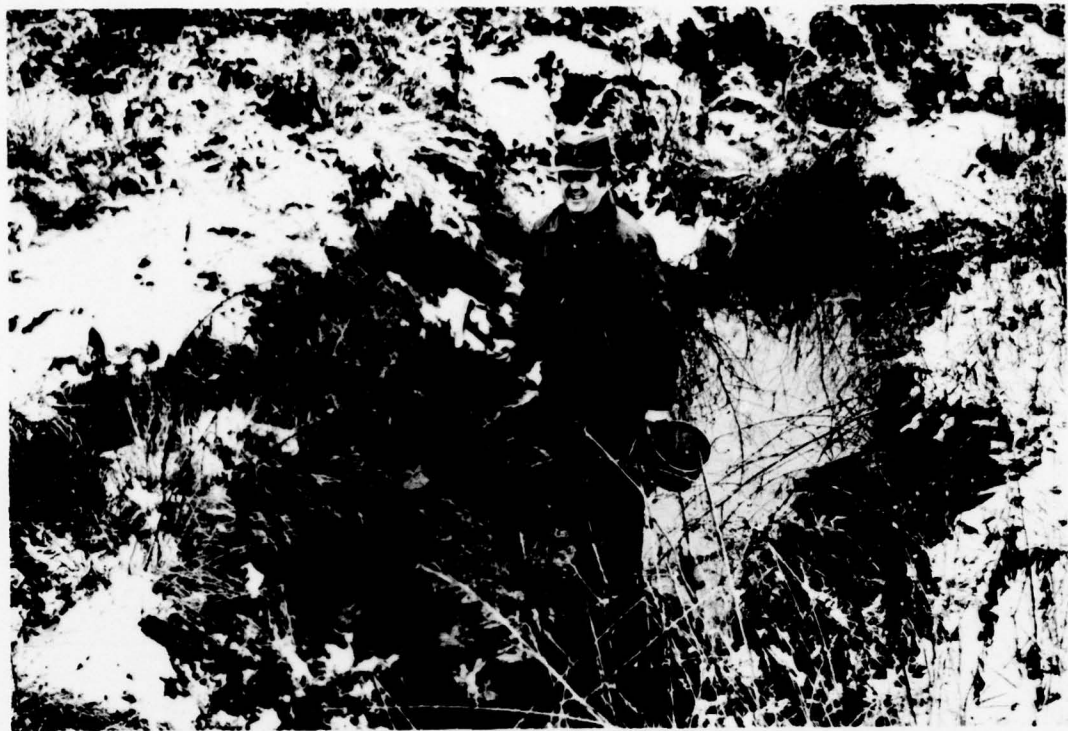
Clear seepage was observed for a 50 foot width at the toe of the embankment 50 feet right of the reservoir drain. The clear seep has no defined flow and flow was too minimal to estimate (less than 1 g.p.m.). A small stream originates in the ditch just downstream from the end of the paved overflow ditch in the vicinity of the clear seepage (see Photo 3).

PHOTO 3. Clear Seepage at End of Concrete Drainage Channel

OUTLET CHANNEL	The paved overflow ditch outlets into loose rocks and weathered quartz monzonite bedrock near the downstream toe of the dam where a stream is formed from clear seepage and/or a small spring in the area (see Photo 3). No water was flowing in the paved ditch which has some cracks (see Photo 2).	
RESERVOIR DRAIN AND CHANNEL	The 10 in. blow-off drainpipe (invert elevation 72.7 ft. P.D.) outlets in a low wet area with some brush. Some of the water flows into the stream channel downstream from the overflow ditch. The outlet valve is closed. Apparently, the water comes from the outlet of the toe drain (see Photo 4).	The channel for the outlets of the blow-off pipe and toe drain should be well-formed to conduct the water into the adjacent stream channel. A stone riprap basin would prevent erosion near the outlets. The consulting geologist Adolf Honkala expressed "apprehensions" about the contractor's use of gasoline pipe for the blow-off drain in the fill.

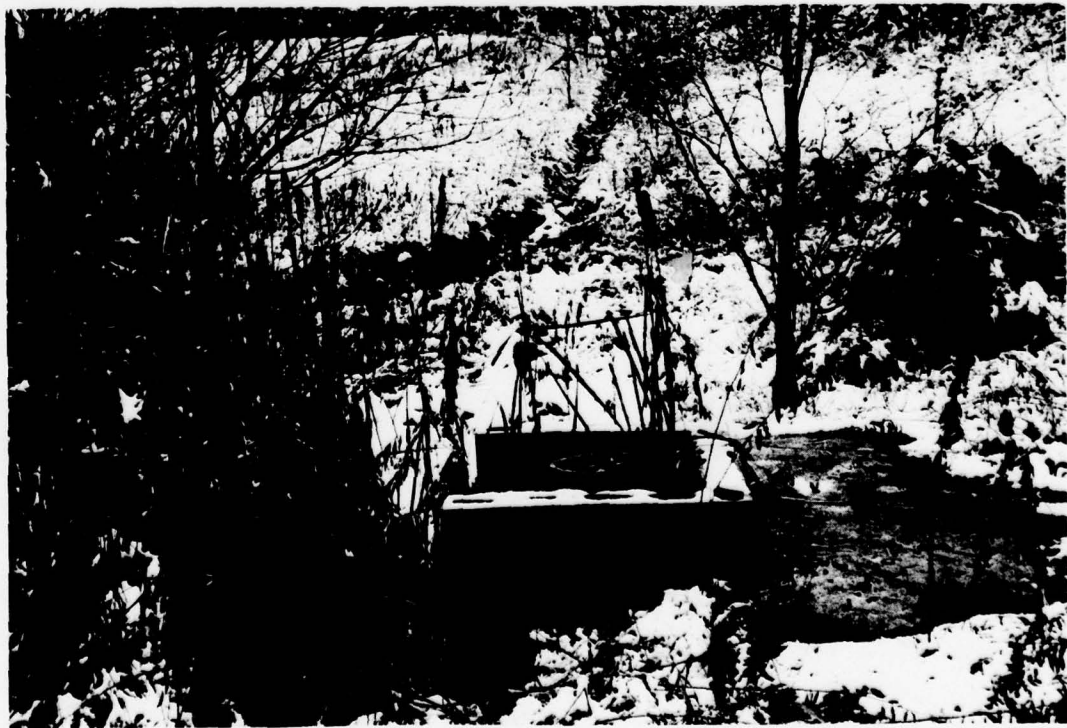
PHOTO 4. Gate Valve on Outlet of Reservoir Drainpipe

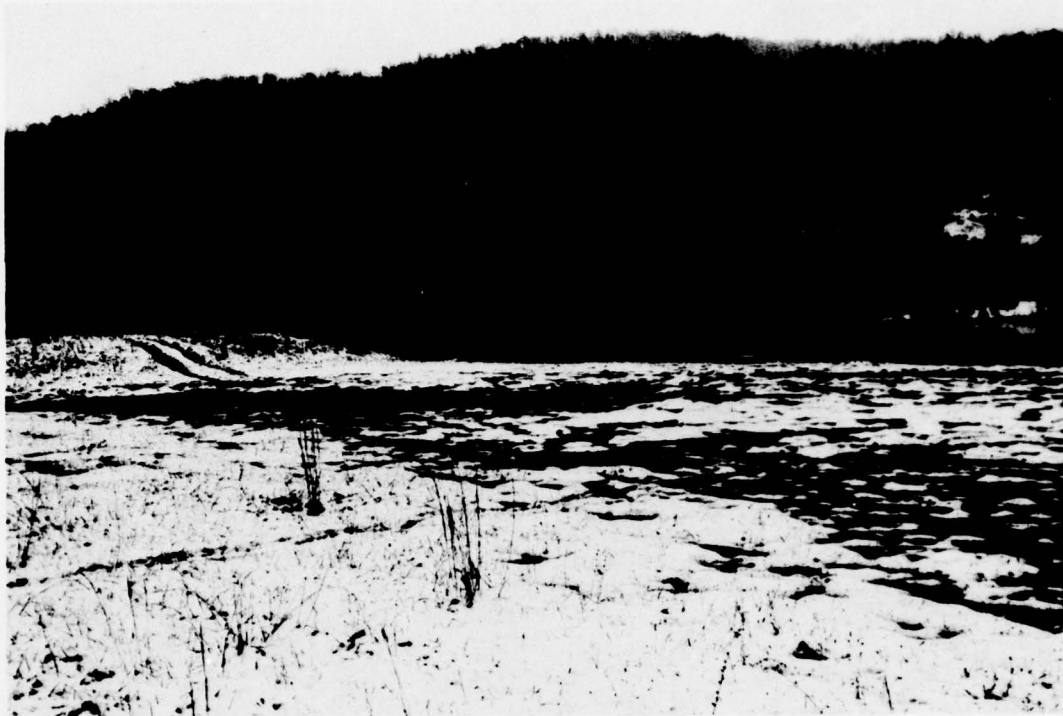
There is minor surface erosion, which has removed portions of the grass cover, in the emergency spillway (see Photo 5). Some clear seepage was observed from the end of the sod in the discharge channel of the emergency spillway (see Photo 6). There are several bare areas on the left cut slope.

PHOTO 5. Left Abutment of Dam and Emergency Spillway

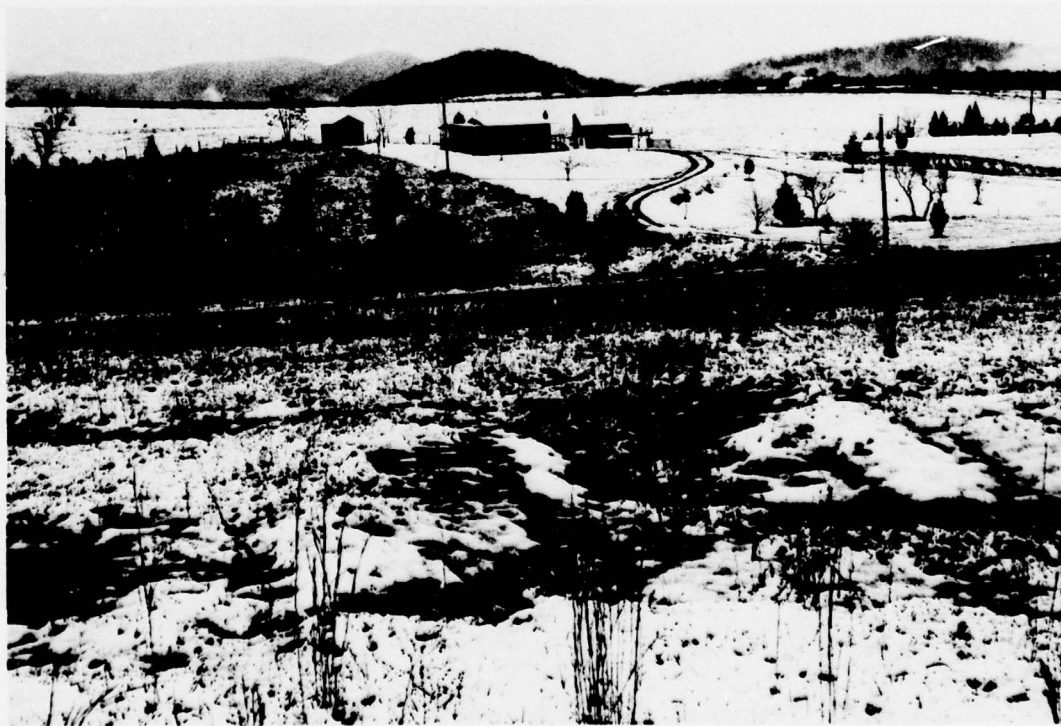
PHOTO 6. Exit Slope From Emergency Spillway

<p>DISCHARGE CHANNEL</p> <p>The upper part of the channel has areas of erosion created, apparently, by the overflow during Hurricane Agnes. Clear seepage was observed from beneath the end of the soil cover. Surface drainage flows down the ditches in red, clayey silt adjacent to the access road on the right side (see Photo 6).</p>	<p>It is recommended that topsoil be placed and seeded in the bare areas to prevent erosion.</p>
--	--
